## Managing Historic Properties in Drawdown Zones at Corps of Engineers Reservoirs: Three Case Studies

Final report

Managing Historic Properties in Drawdown Zones at Corps of Engineers Reservoirs: Three Case Studies (TR EL-96-14)

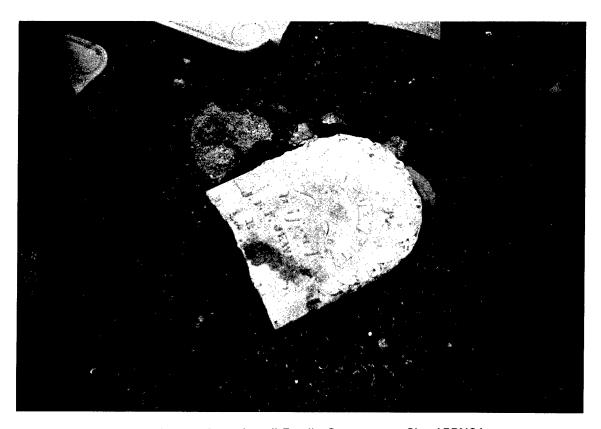
(Figure 7). The historic cemetery was moved to another location during the construction of the lake.

Figure 7. Broken tombstone from Jewell Family Cemetery at Site 15BN21

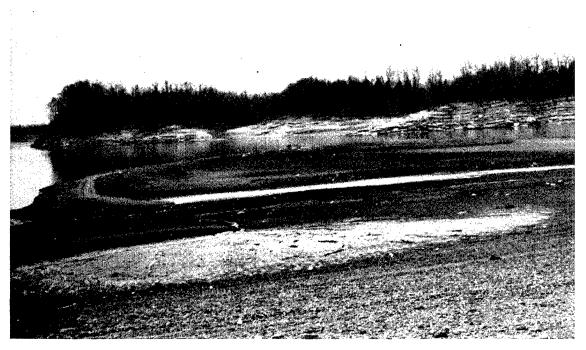
Protection of the site from continued erosion from wave and runoff erosion could be a costly challenge. Fundamentally, the site surface would need to be protected from erosive processes. The substantial depth of water over the site during full reservoir level would probably make the use of vegetation

Figure 8. View of Jewell Mound (15BN21)

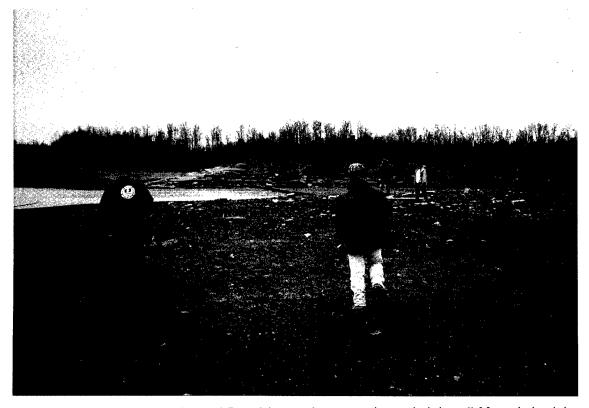
Figure 9. WES team (Taylor and Dunn) inspecting severely eroded Jewell Mound site (photo by Hollis Allen)

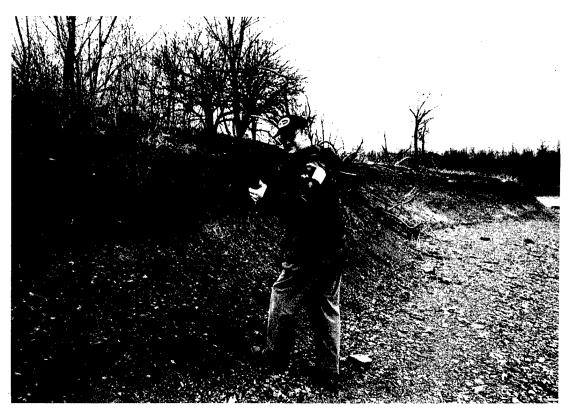
A sketch of the profile of Site 15BN384 (east-facing) shoreline is shown in Appendix A. The principal geomorphic processes that are contributing to the steady wasting of the site appear to be wave attack throughout the shoreline and hydration/desiccation of the sandy shale deposits underlying the terrace. Material is also being removed from the site by lessor amounts of overland

Figure 10. Hollis Allen examining village midden in eroding cut bank at 15BN384 (photo by Hugh Taylor)

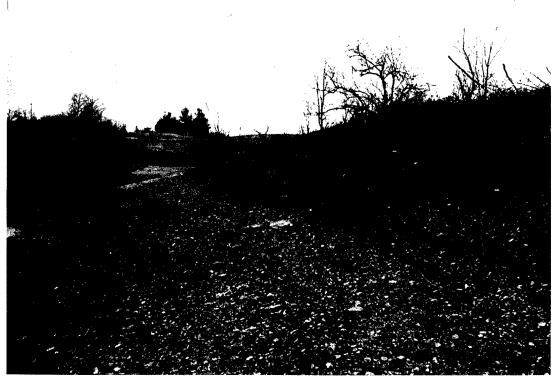
Figure 11. Site 15BN384: Eroding shoreline at top of summer pool elevation (photo by Hugh Taylor)

Arresting shoreline erosion at Site 15BN384 will be a substantial challenge and should be considered in terms of both short-term and long-term solutions. Immediate protection of the summer pool elevation on the shoreline could be

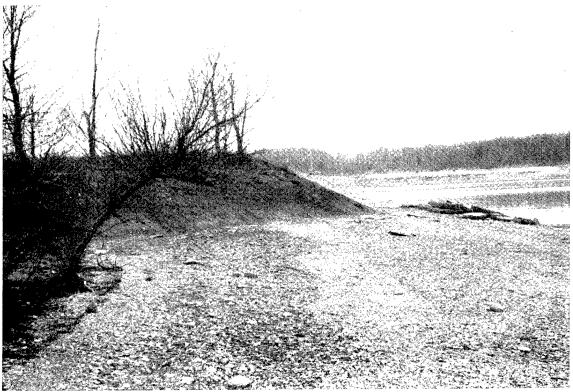
Figure 13. View of severely eroded shoreline at Site 15BN349

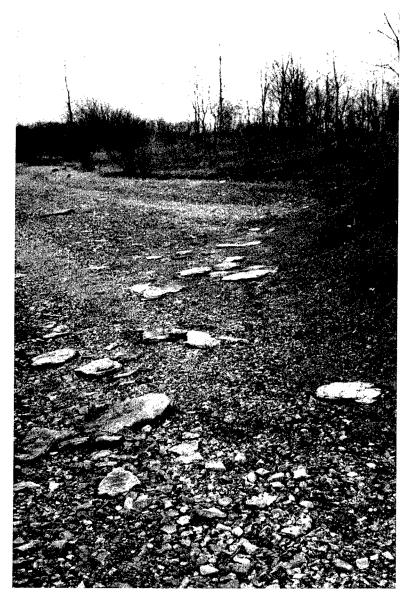
Figure 14. Site 15BN349: Stone box grave fragments dispersed by shoreline erosion and wave attack

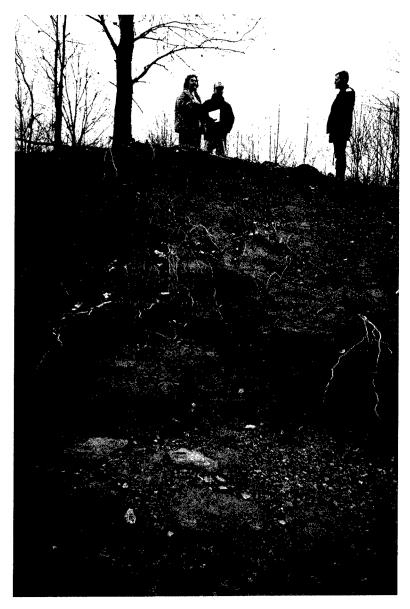
Figure 15. Ranger Lloyd Crabbe with Anne Bader and Robert Dunn at 15BN349 disarticulated stone box grave fragments in foreground

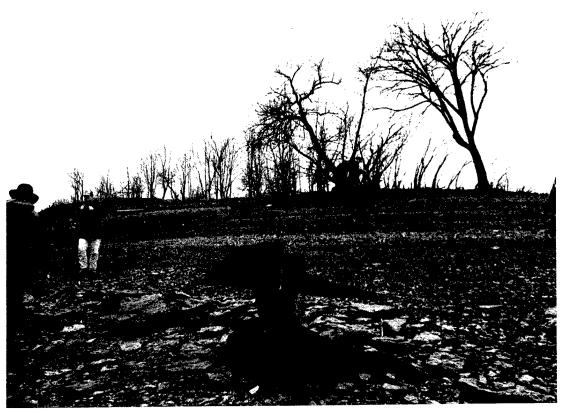
Figure 16. Site 15AL329: Highly eroded surface with disarticulated stone box graves (photo by Hugh Taylor)

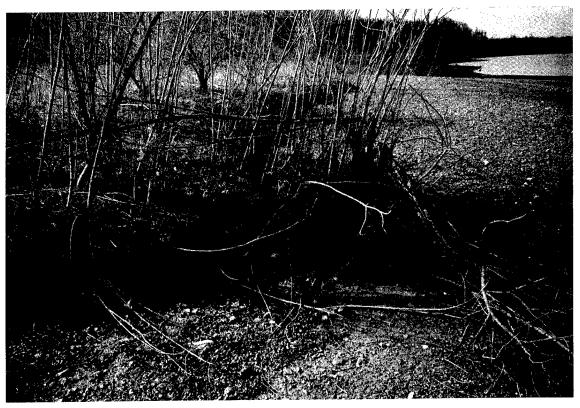
Figure 17. Vegetative mat just above summer pool elevation at 15AL329

in place (Figure 17). The willow contained young saplings with a dense root mass that was impenetrable to waves. The shore geometry was gradually sloping lending itself to some sort of bioengineering stabilization, i.e., a combination of vegetation and low-cost materials and structures. Soils at the site that were at or above summer pool tended to be well drained and appeared to be sandy silty clay. At the summer pool elevation, there was about a 2-ft escarpment that was a result of wind-driven wave action.

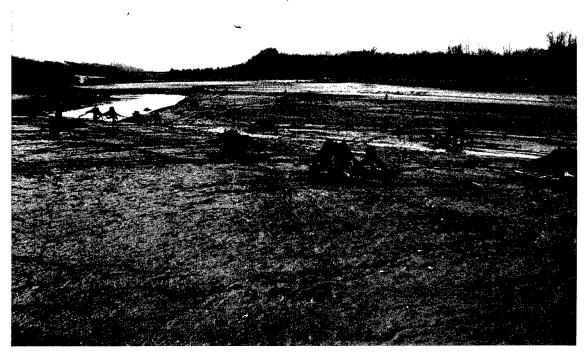
Unlike the two previously discussed sites, Site 15AL8 occurs next to the Barren River in the upstream reach of the reservoir. The site is the location of one of several previously identified artificially constructed mounds. Located immediately adjacent to the Barren River, the mound is situated on top of a low (approximately 2 m above the floodplain) fluvial terrace (refer to Appendix A). The mound has been eroded by both waves (as the reservoir level rises and falls on the mound) and streamflow. Several stumps on the site indicate that 40 to 60 cm of the original soil surface has been removed by these processes since the closure of the reservoir. Fine-grained silty sediments are also accumulating on the site during the falling stage of the reservoir to depths of 20 to 30 cm. These sediments are probably being stored in this constricted part of the reservoir until the next substantial filling event occurs and the easily eroded silts are moved downstream into the main pool of the reservoir (Figures 19-22).

Figure 19. Site 15AL8: View from mound

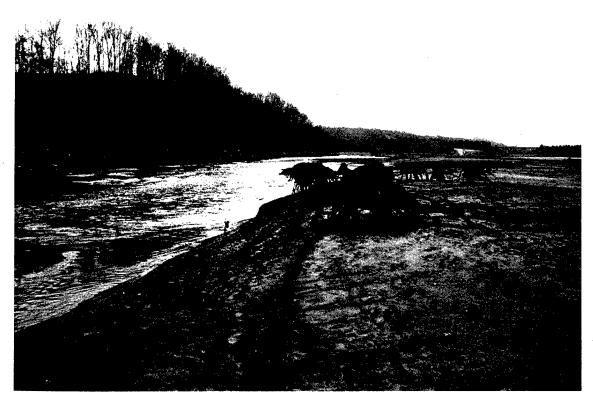
Figure 20. Site 15AL8: View of eroded terrace adjacent to river

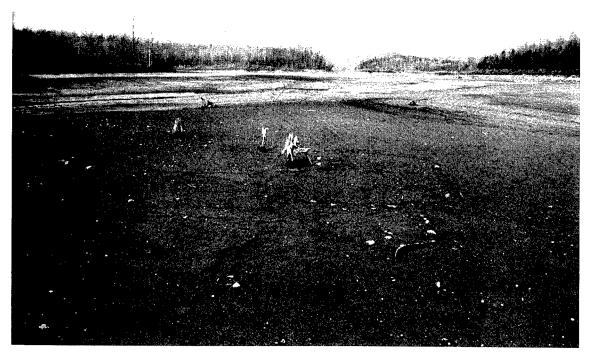
Figure 22. Site 15AL8: Eroded mud flat adjacent to mound

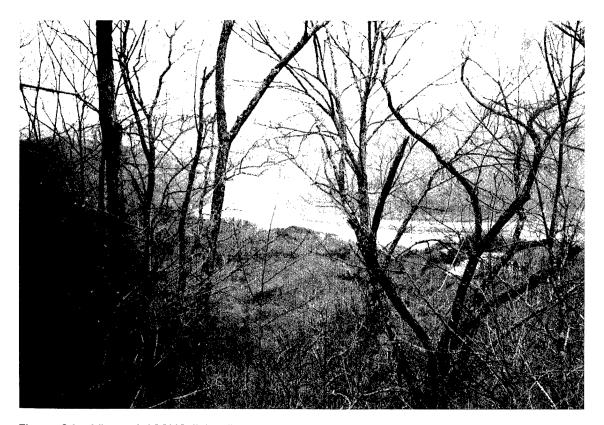
Located on a low terrace of the New River, the landform that contains Site 46SU3 is now inundated by the normal summer pool. Annual transgression of the rising pool in spring and regression of the falling pool in the fall has resulted in erosion of approximately 70 to 110 cm of surficial soil from the site. The creation of the reservoir left the small ridge on the low terrace (which may have been the nucleus of the prehistoric occupation area) as a narrow island (Figure 24). The upstream end of the island has been subjected

Figure 24. View of 46SU3 (island) from uplands

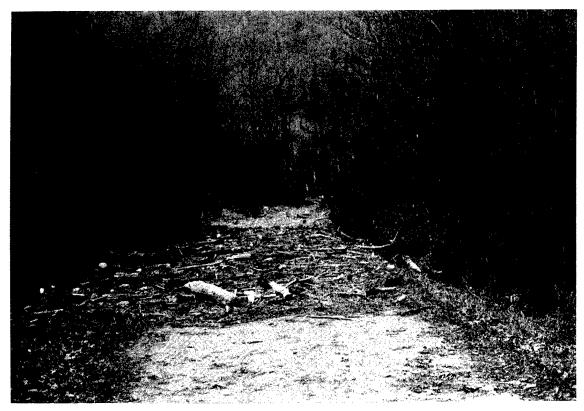
Figure 25. Bluestone Lake: Trash line showing elevation of 85-ft flood storage in January/February 1996

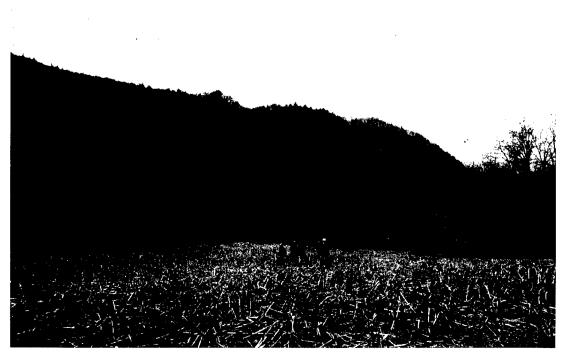
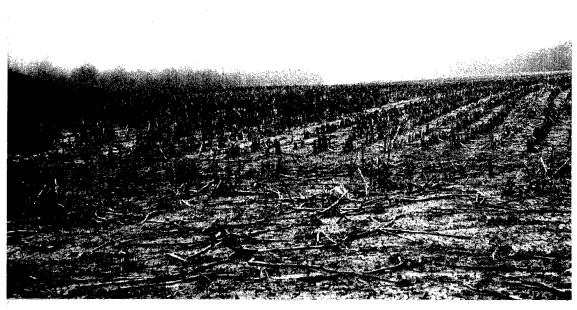
The principal process of negative site impact at Site 46SU22 is disturbance of the soil by cultivation. Annual cycles of plowing, planting, cultivation, and harvesting of corn in Crumps Bottom is having a deleterious effect on the integrity of the site. Artifacts of the archaeological record are being broken, crushed, exposed, unofficially collected, and geochemically altered as a result of corn cultivation on the site. Sedimentation from floods has the positive

Figure 30. WES team at 46SU22 with Dr. Robert Maslowski (photo by Hugh Taylor)

Figure 31. View of fertile bottomlands at 46SU22

The site is located on an old river terrace with ridges and swales in the terrace (Figures 30 and 31). The site is presently being cultivated for corn and has bottomland hardwood forests occurring at the edges of the fields. The corn fields in the area are estimated to be about 300 acres in size. The bottomland hardwood forests consist of various species including black willow, sugar maple, red maple, and others. The bottomland hardwood forests and the wetlands in the area were abundant with deer, turkey, squirrel, and waterfowl, all of which were observed in the area. The field containing the site had several centimeters of sediment deposited on it from a near record flood that occurred in January 1995. There was little residual corn grain left on the corn husks in this field at the time of observation.

impact of burial and partial protection, but is not sufficient to protect the site from the damage of cultivation. One possible solution that would partially protect the site while allowing the production of corn is the practice of no-till cultivation of corn. In the practice of no-till cultivation, plowing to prepare the seedbed is not conducted, and plant residues are left on the surface. Seeds are usually planted with a drill. No-till cultivation results in far less soil disturbance and fewer tractor trips across the site surface.

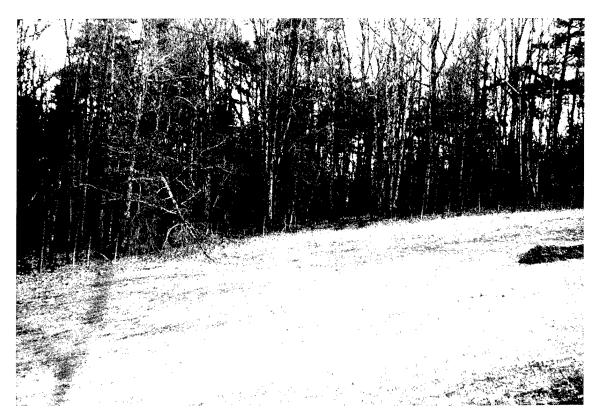
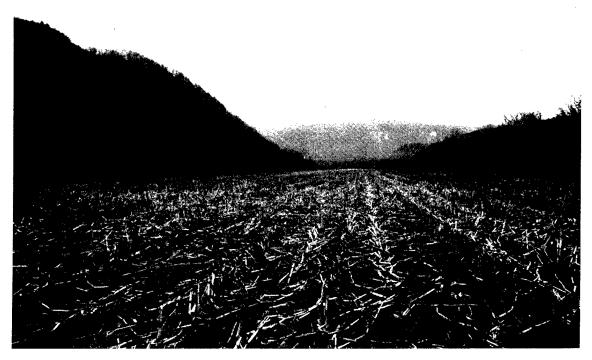
The landscape setting of Site 46SU20 is very similar to 46SU23 with the exception that the amount of sedimentation that is apparently occurring on the site during falling floods is less. The site is also situated on the high terrace of Crumps Bottoms (Figures 32 and 33). Subsurface examination of soils at the site revealed soil strata similar to Site 46SU22. Corn cultivation is impacting Site 46SU20 more profoundly than at 46SU22 because of the reduced level of sedimentation that would serve to partially protect the site. Reduction of the impact of traditional methods of corn cultivation at Site 46SU20 is particularly urgent.

Figure 32. View of Site 46SU20: Looking toward New River (photo by Lawson Smith)

Figure 33. View of narrow valley at Site 46SU20 (photo by Lawson Smith)

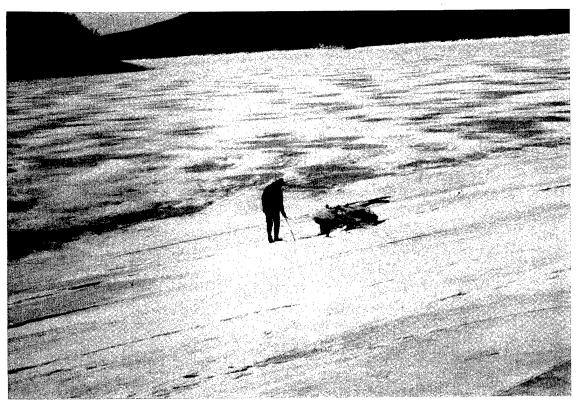
Allegheny Reservoir is normally operated with a fluctuation of 28 ft between summer (1,328 ft msl) and winter (1,300 ft msl) pool levels. The maximum pool level of design is 1,365 ft msl, with an actual maximum level of 1,362.17 ft msl achieved in June 1972. The conservation pool is designed for 1,240 ft msl, but the low pool of record was 1,282 ft msl. The reservoir is typically frozen in winter during low pool levels. Spring thaws usually occur in late March or April. During the WES team's reconnaissance of 12-14 March 1996, most of Allegheny Reservoir was covered in ice to a depth of 8 to 10 in. (Figure 35).

Figure 35. Frozen reservoir at Willow Bay near Riverview/Corydon Cemetery: Lawson Smith standing on lower bench between outwash terrace and underlying Paleozoic bedrock

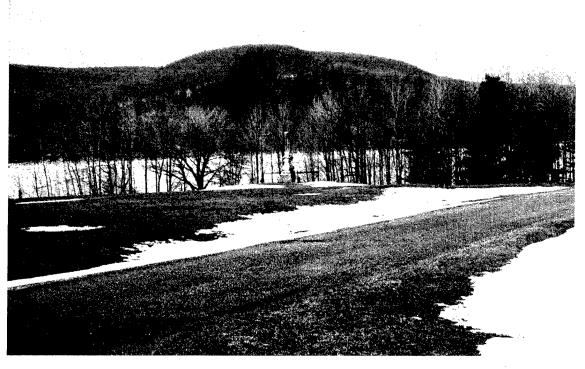
Wave erosion is threatening the historic Riverview-Corydon cemetery. In a 1995 status report to the Corps, Forest Service archaeologist Robert Scott reported the following:

"Wave action, and the erosion it produces, has been responsible for another concern on the reservoir. The west facing slope to the Riverview/ Corydon cemetery has eroded significantly since 1964. The surface and subsurface material in this area was deposited during glacial periods. It is a combination of sands, gravels, and sandstone conglomerate stone deposited by glacial outwash. This sort of geology does not lend itself to stability under normal conditions. Wave action from fluctuating water levels, spring storms,

Figure 36. Complanter Memorial at Riverview/Corydon Cemetery - Allegheny Reservoir

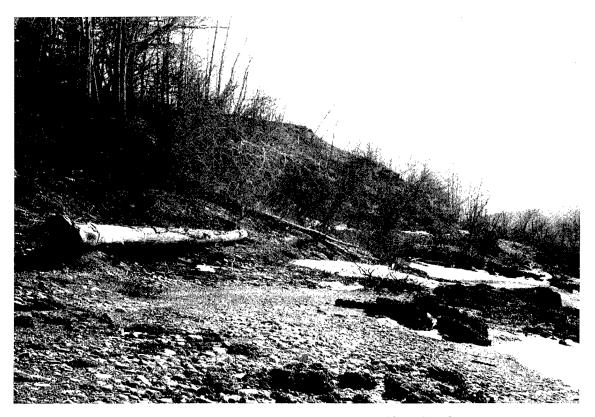
Figure 40. Erosion along west face of bluff below Riverview/Corydon Cemetery

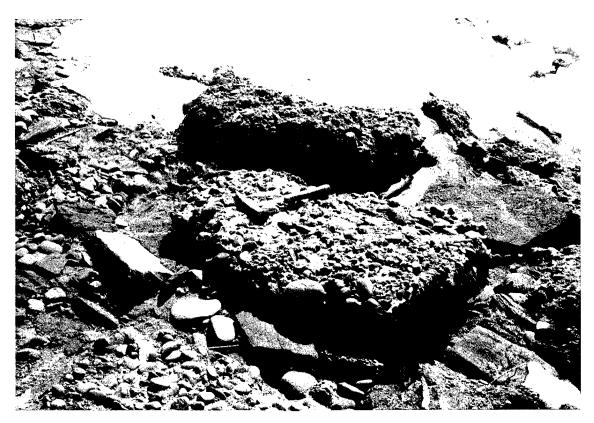
Figure 41. Calcium carbonate conglomerate at Riverview/Corydon Cemetery

The cemetery is underlain by glacial outwash deposits of sand, cobbles, and boulders. Interestingly, the outwash deposits are being cemented by calcium carbonate precipitation upon exposure to the near-surface fluctuation of soil moisture to form a conglomeratic ledge near the top of the site (Figures 36 and 37). Carbonates are also being precipitated in a sand facies beneath the conglomerate to form a weakly indurated sandstone. These materials fail in mass upon removal of basal materials at the summer pool level. Destructive geomorphic processes active at the site include wave breaking and swashing, ice gouging and battering, overland flow, and soil falls and slides from the toe of the shoreface to the top, respectively. A berm in unconsolidated gravely sand occurs about 6 ft above the elevation of the summer pool at the steepest face of the site. This berm may represent a wave-cut bench produced during a high (above summer pool) flow event (Figure 37). A lower bench was observed at an elevation approximately 10 ft below the summer pool level on the shoreface. Comprised of local sedimentary rock, this bench may represent the contact between the base of the outwash terrace and the underlying Paleozoic "bedrock" (Figure 35).

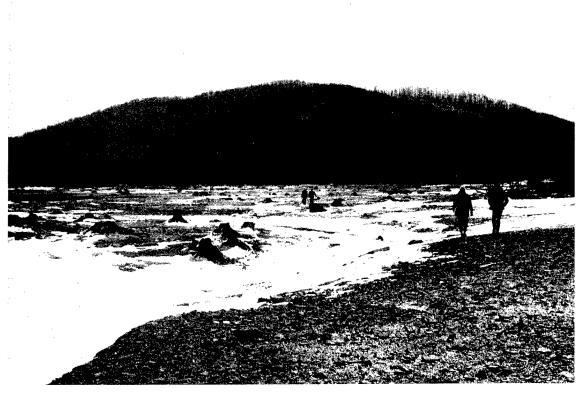
The "Red Bridge" sites may represent an example of the type of cultural resources where CRM efforts may be the most productive in the Allegheny Reservoir project area (Figures 43 and 44). These sites in the tributary valleys may have experienced the least amount of damage from reservoir fluctuation. Situated in alluvial valleys that have aggraded in response to the Allegheny River, the possibility of the existence of buried undiscovered sites in these areas is significant, particularly for older (Archaic) sites.

Red Bridge is approximately 8 miles upstream on Kinzua Creek above its confluence with the Allegheny, at its confluence with the South Branch of Kinzua Creek. The sites are located on the prereservoir floodplains of Kinzua Creek and its south branch. The stratigraphy of the upper several feet of the area consists of fine-grained vertical accretion deposits from the tributaries. The deposits offer little resistance to wave processes when the area is covered by 4 to 8 ft of water during summer pool. Exposed stumps in the area indicate that although some sedimentation does occur at the site, the net is steady erosion, as much as 2 ft. Many previously identified cultural features have been eroded from the area.

Figure 43. View of Red Bridge site area - Allegheny Reservoir

The consideration of enclosing the area in a "sub-impoundment" for various resource management objectives has promise of providing protection of the area from erosion as well. In fact, the "sub-impoundment" would result in some sedimentation, serving to protect the sites in the area.

Since these sites are covered by 3 to 5 ft of water during summer pool and include such a broad area, a site protection plan consisting of vegetative cover would be impossible. However, bioengineering treatments could be applied in upper tributaries and at the edges of the summer pool if cultural resources are found in those areas and protection is deemed warranted. If these areas need protection, then treatments such as those discussed next for the Nelse Run area may be plausible.

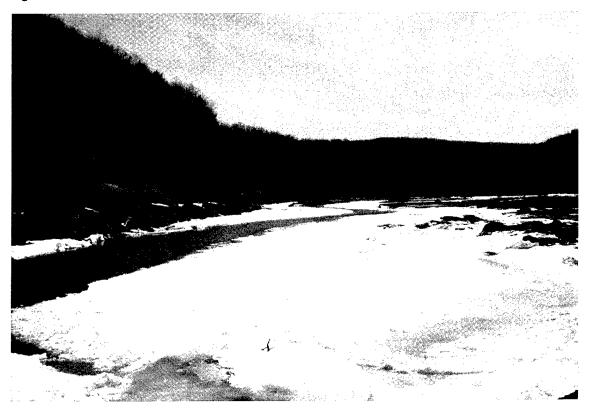
Figure 44. Winter drawdown at Red Bridge site area - Allegheny Reservoir

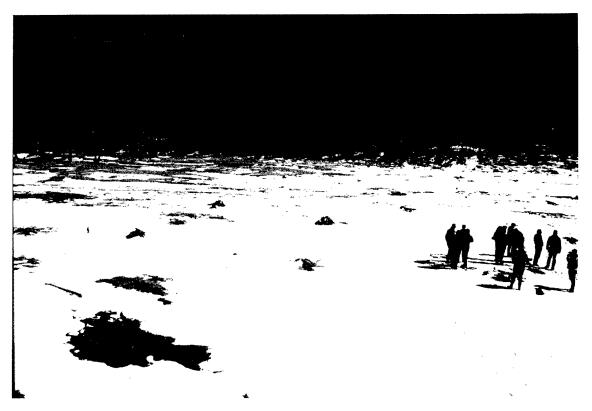
Located in a tributary mouth, the Nelse Run Site has been substantially eroded by wave breaking and swash (Figures 45-48). Although sediment is being contributed to the area by Nelse Run, this sediment is being effectively removed during pool fluctuation (transgression and regression). Before the creation of the reservoir, the site was the locus of net sedimentation, possibly serving to bury and preserve the cultural record. There may still be buried components of the cultural record on the site above the summer pool level (in the area covered by trees). Exposed stumps at the site indicate soil erosion of several (2 to 3) feet through most of the shoreface.

Figure 45. Nelse Run site area: WES team meeting with Corps and Forest Service personnel

The long shallow shoreface and thick alluvial deposits of the Nelse Run site lends it to erosion control by vegetative schemes. Although much of the site has been removed by erosion, the northern (upslope) parts of the site may still have buried components of the cultural record and warrant consideration for protection.

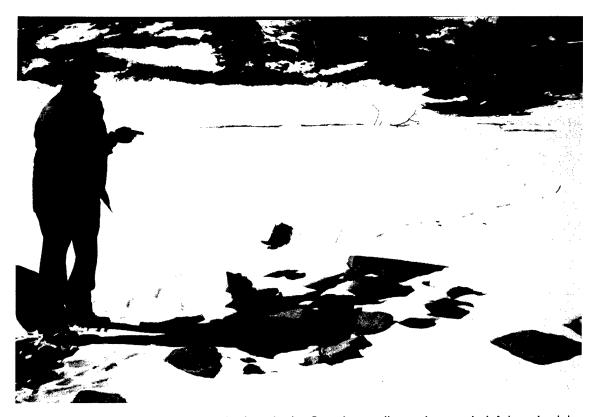
Figure 46. Nelse Run site area: Archaeologist Stan Lantz discussing eroded Adena burial mound

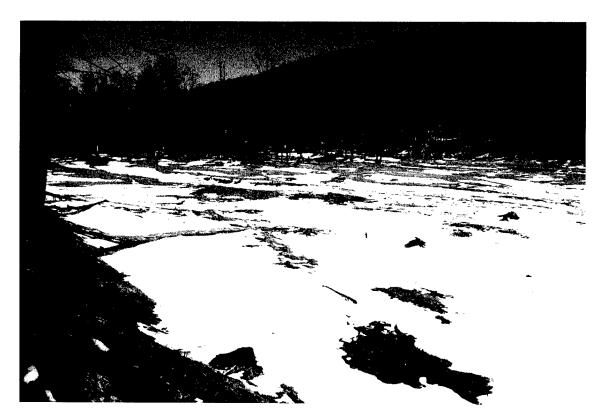
Figure 47. Nelse Run site area: Area in trees is recommended for testing

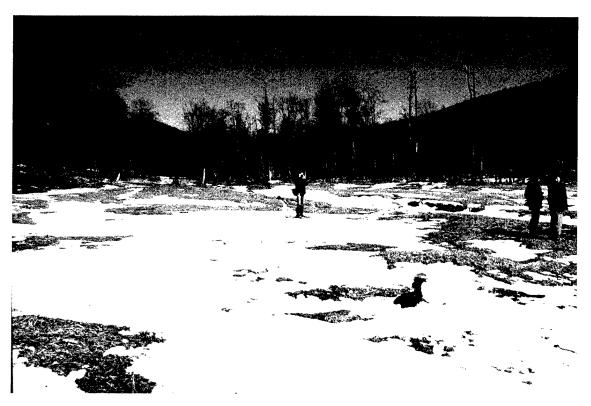
Figure 48. Nelse Run site area: Robert Dunn videotaping onsite meeting with Corps and Forest Service personnel

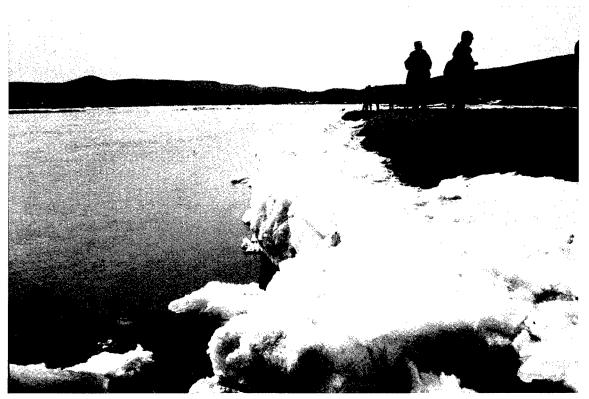
Figure 50. Steamburg site area: Ice gouging and plucking of riverbank during winter drawdown
